# Manhole Inspection Summary

Manhole # S15Y\_\_001MH

Insp Date: **6/25/08 9:08 AM**

**Location** Address: **2625 georgetown rd**

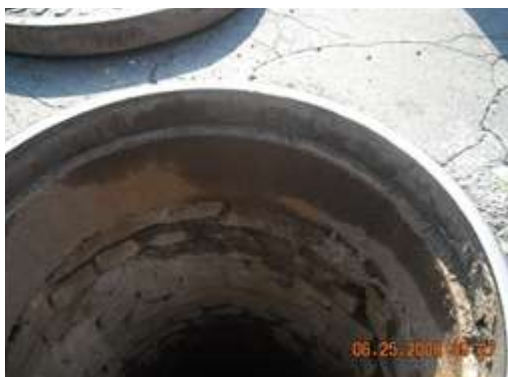
Misc

Subject To Ponding: **Sheeting**

inflow evidence from sheeting

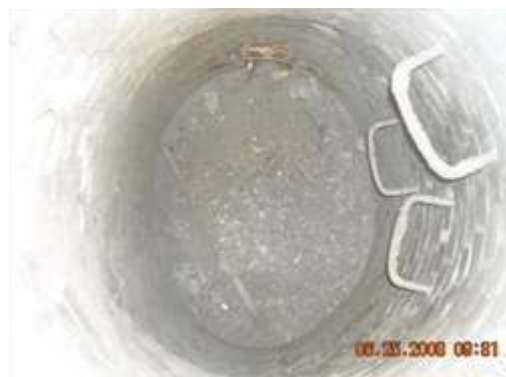
Defect 5

Condition: ☐ Sound ☐ Cracked ☐ Root Intrusion ☐ Deteriorated ☐ Leaks ☒ **Debris**

debris in terminal channel

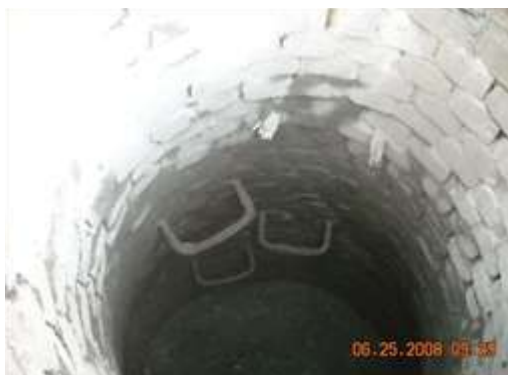
Defect 4

Count: **3** Missing: **2** ☒ **Corroded**

corroded & missing steps

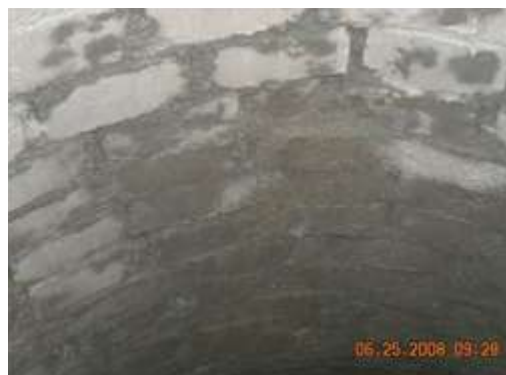
Defect 3

Infiltration: ☐ None ☐ Joint ☐ Cracks ☐ Mortar ☐ Roots ☒ **Wall**

infiltration @ corbel wall

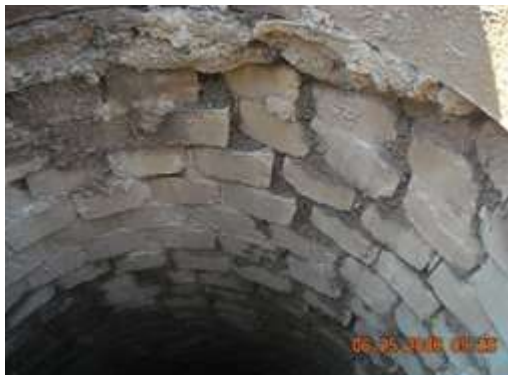
### Defect 2

Condition: ☐ Sound ☒ **Cracked** ☐ Root Intrusion ☐ Loose Brick ☐ Deteriorated

cracked corbel

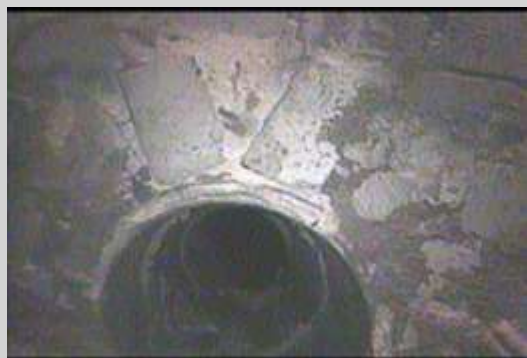
12 O'Clock Outflow

8 in. Circular Gravity Sewer  
Pipe Out @ 12 O'Clock

Deposits: ☐ None ☒ **Mud** ☐ Sludge ☐ Debris ☐ Grease

Silt Depth: **1** (in.) Deposits Extent: **Light**
